# '67 FENDER BAND-MASTER AMP AB763

# '67 Band-Master

Original project by dbishopbliss, Oct, 2013  
Revised by sluckey, Mar, 2019

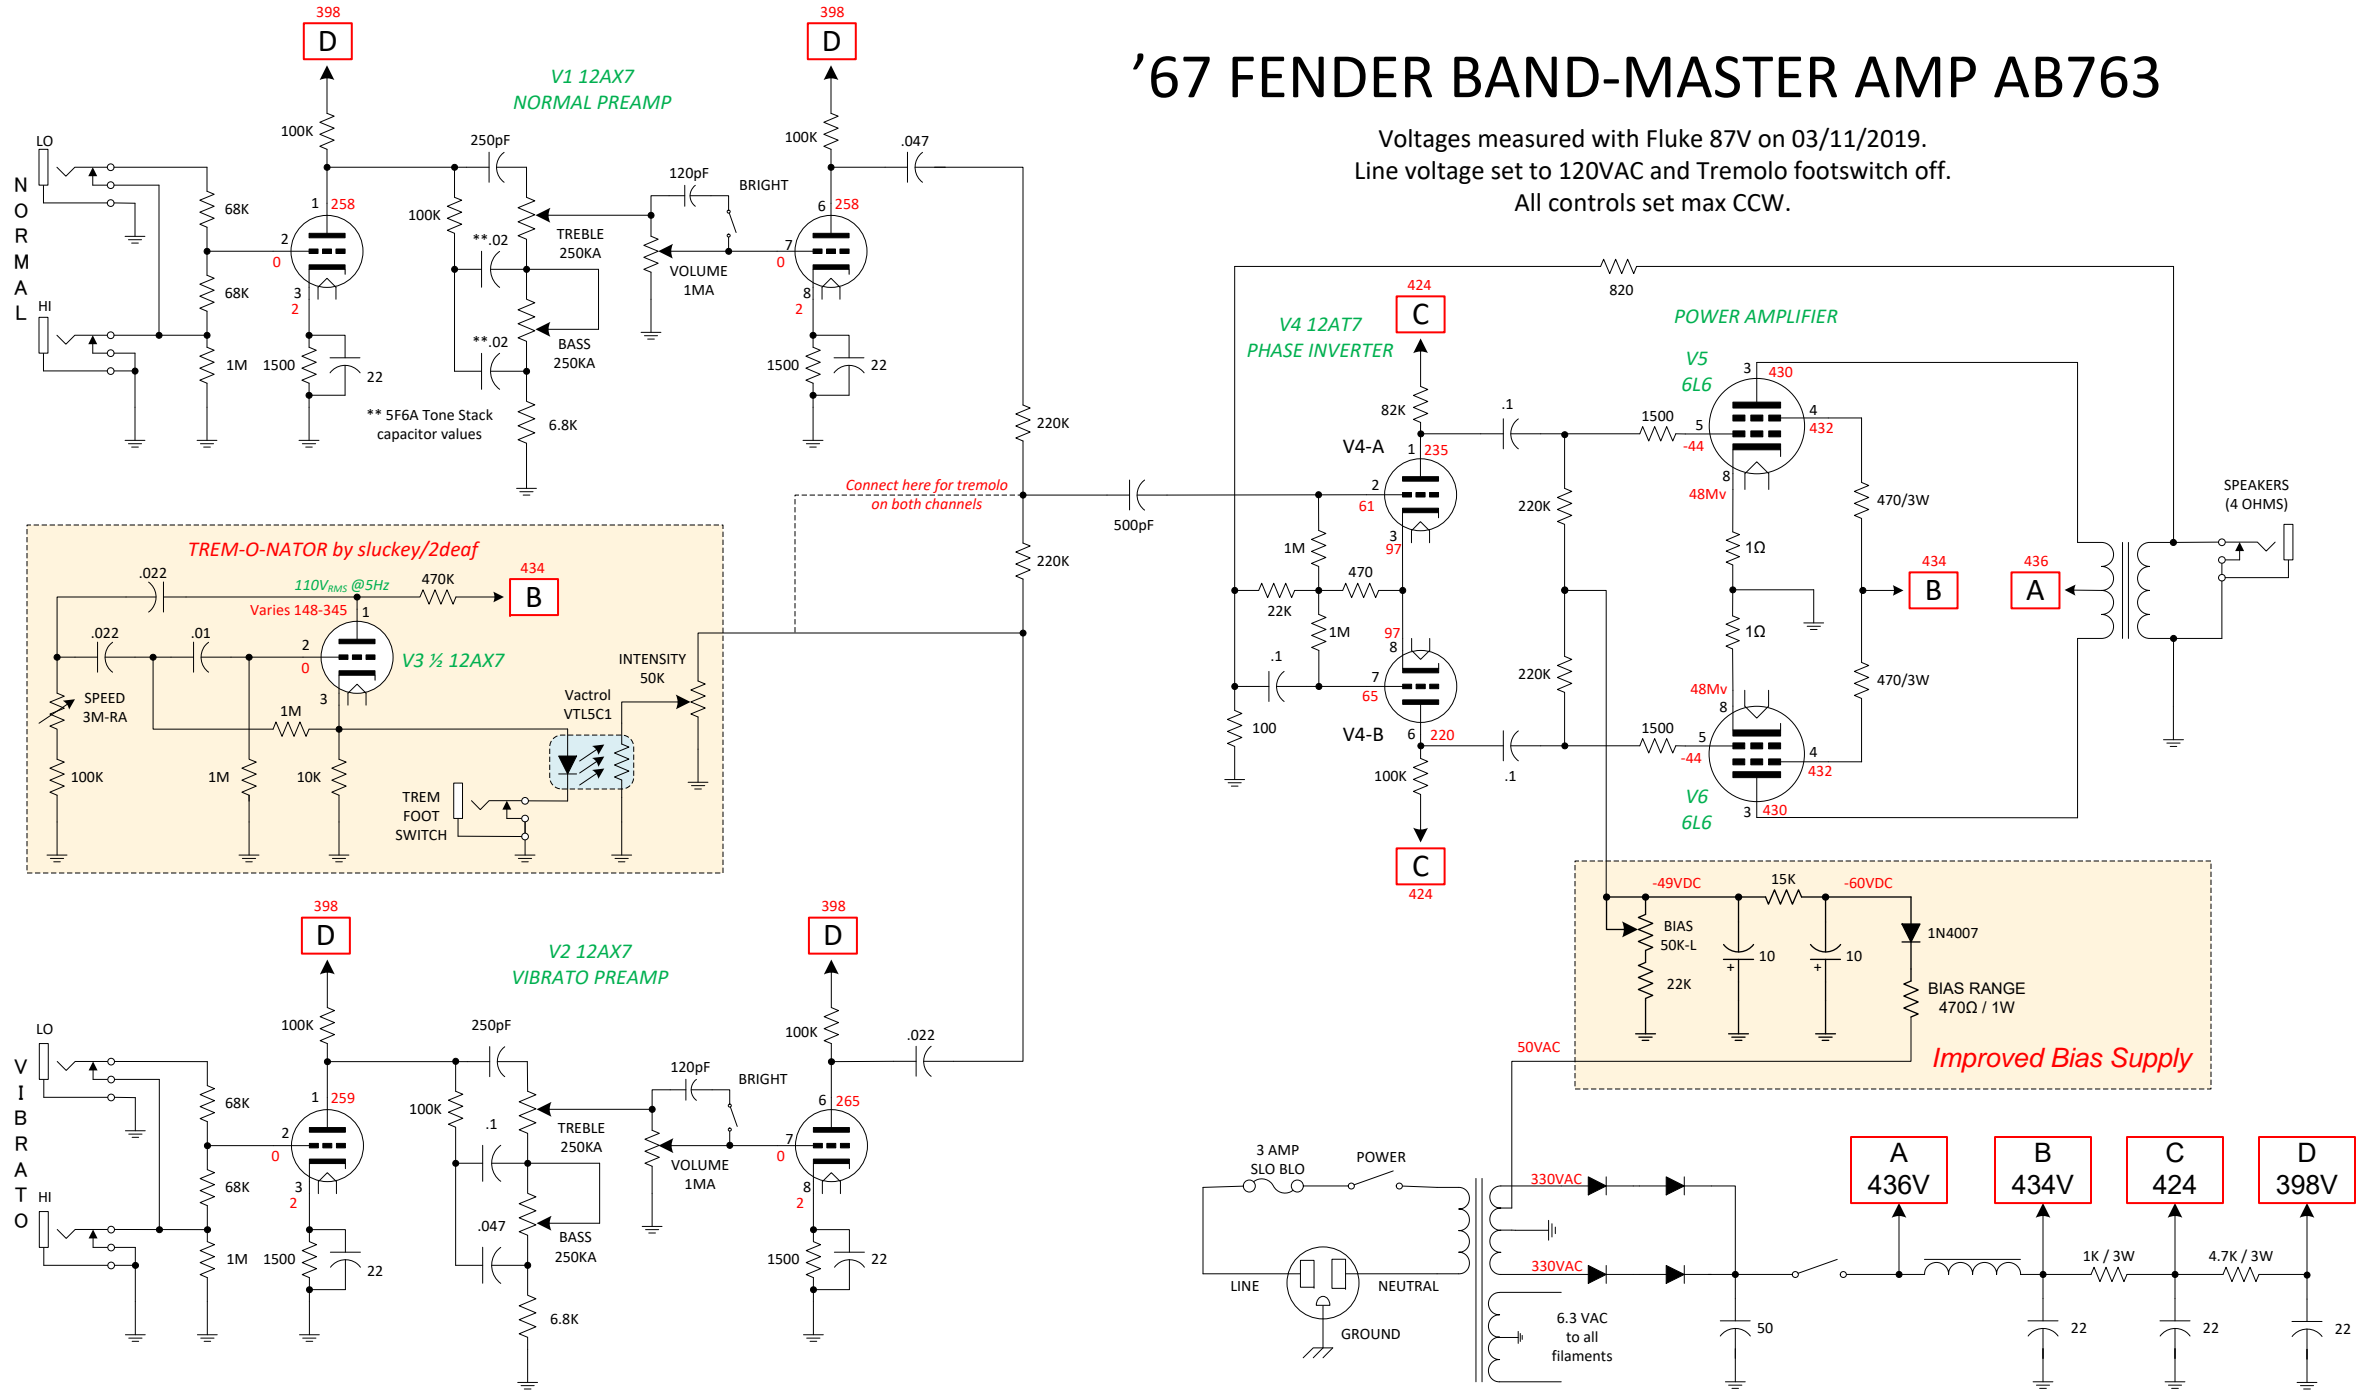
Voltages measured with Fluke 87V on 03/11/2019.  
Line voltage set to 120VAC and Tremolo footswitch off.  
All controls set max CCW.

- Black wire on B+ diode terminal strip never soldered..
- Bad solder connection/broken lead on top 100 $\mu$ F/450V reservoir cap.
- Second bias cap positive end never soldered.
- 47K resistor in bias circuit never soldered to ground turret.
- 220K grid bias resistor for V6 never soldered.
- CHNL 1 250pF treble cap never soldered.
- 50K INT pot should be 250K.

- Removed reservoir cap/terminal strip assembly.
- Removed diode/terminal strip assembly.
- Added cap can for reservoir cap.
- Installed diodes on board.
- Replaced INT pot with correct pot.
- Replaced 47K bias resistor with 22K for proper 6L6 bias range.
- Replaced 4.7K/25 $\mu$ F tremolo oscillator cathode components with red LED.
- Modified tremolo circuit to Trem-O-Nator circuit. (shown below)
